# Manhole Inspection Summary

Manhole # S15KK1014MH

Insp Date: **12/5/06 2:47 PM**

**Location** Address: **2808 EDGECOMBER CIR**

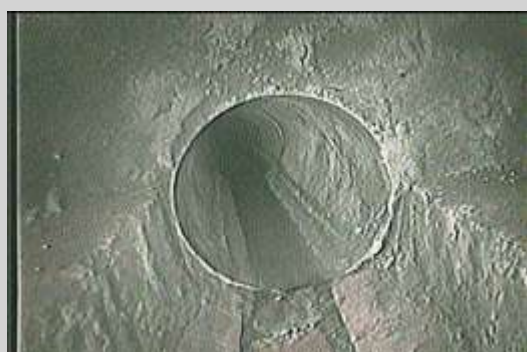
Pipe In @ 6 O'Clock

Rod and Bar (Angled)

Pipe Material: **Clay** ☒ Pipe Lined

Infiltration: **None** Pipe Seal Cond: **Unknown**
